Vol. VIII, No. 9
September, 1948

the Lineman

RURAL ELECTRIFICATION ADMINISTRATION - U. S. DEPARTMENT OF AGRICULTURE

MEMBERS OF CREW, TRAINED IN FIRST
AID, APPLY ARTIFICIAL RESPIRATION
IMMEDIATELY, BUT UNSUCCESSFULLY

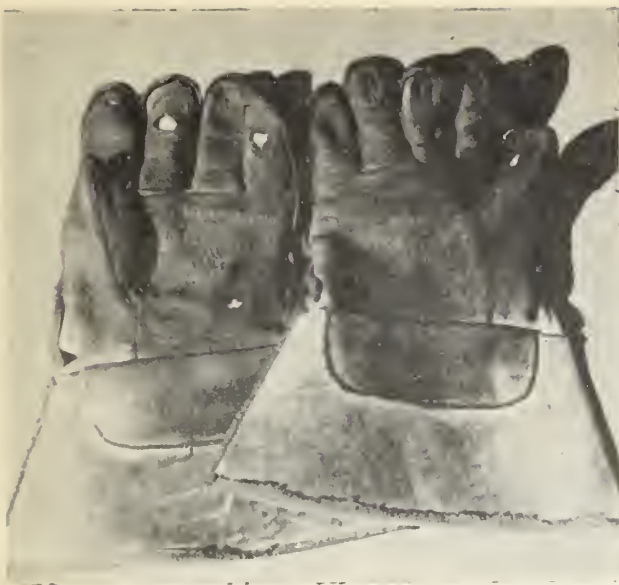
Burns on the hands indicated the path of current through his body was into his right hand and out the left. He was holding onto the cross arm brace with his left hand and had grabbed the energized jumper coming from the bottom of the breaker, with his right hand. To do this, he had to step up from the position he was in when last seen by the foreman..

The gloves victim was wearing at the time of the accident. Burns on hand correspond to holes burned in gloves.

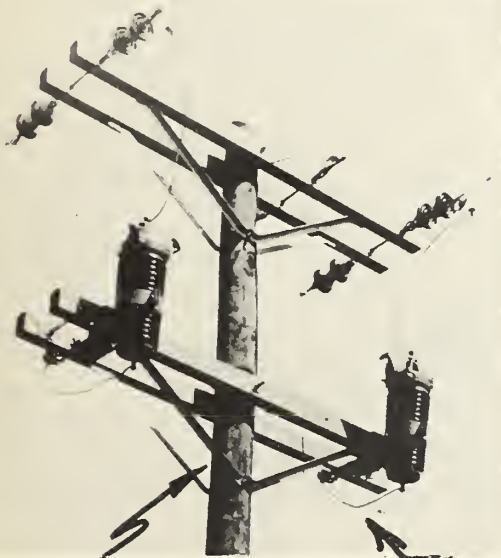
Smudged spot on brace indicates position of left hand.

Point at which victim grabbed jumper with right hand.

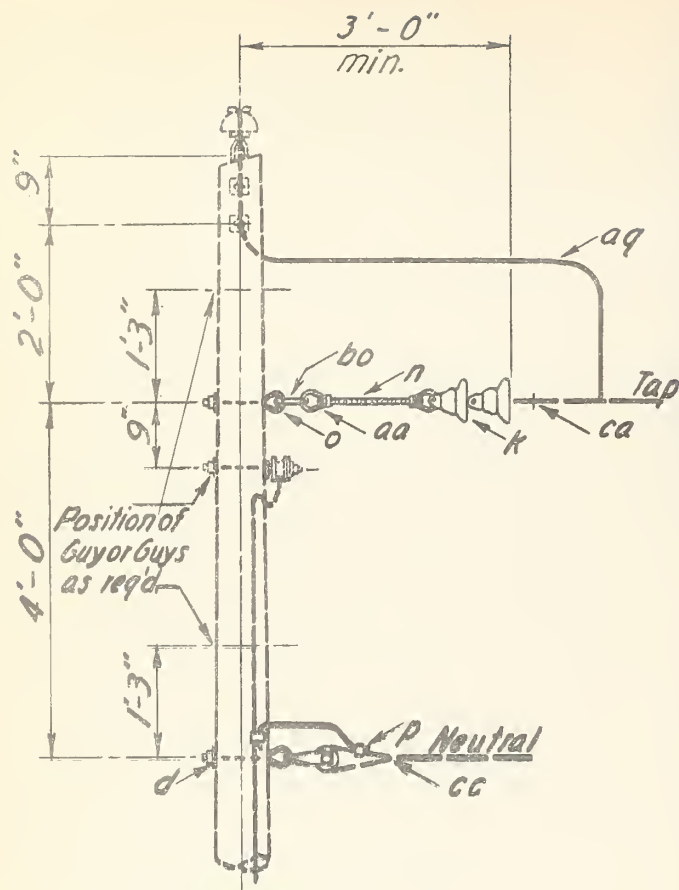
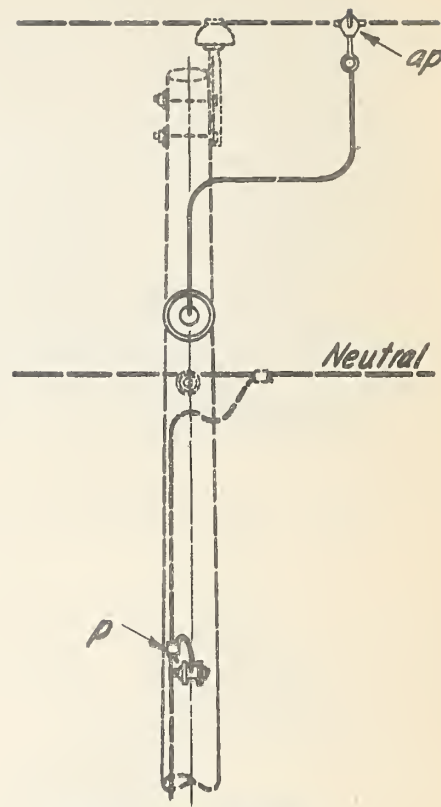
A2-2

At the Safety and Job Training Conference in Washington last fall the State Safety and Job Training instructors requested REA to change its specifications so that the eyebolt supporting the primary take-off of an A-5 addition to an A-1 or A-2 specification be lowered to a point 6 inches below the bottom of the pole top pin. This suggestion was made to provide more working clearance for the lineman boring the hole for the eye bolt. Several electric shock accidents had occurred in connection with the boring of this hole on energized lines.

After discussing the suggestion in Technical Standards Committee 'A', REA engineers felt that the suggestion had merit. It was unanimously agreed to accept the recommendation of the State safety instructors. To provide the maximum safety factor, it was decided to lower the eyebolt location to a point 33 inches below the top of the pole which materially increased the clearance requested.

A similar arrangement of tap and neutral position should be used for taps from Vee and Three phase lines in preference to those now shown for such assemblies on drawings B21, B22, B23, B24, B27R, C21, C22, C23, C24, C25, C26, C27R, C28R, C29.
